**NEW
3D AOI**

Innovative
Inspection of PCB
Top and Bottom
Sides

iS6059 Double-Sided Inspection

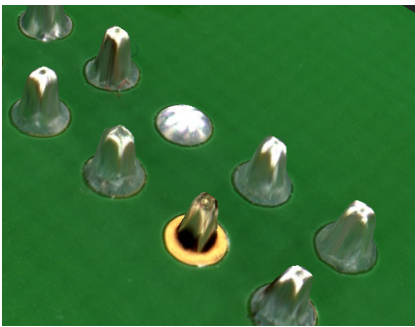
Insufficient wetting (front) and missing pin (back)
